Access Study to all Pertinent Parts of
Dam Projects During High Reservoir
Conditions

Naugatuck River Basin Connecticut

February 1989

New England Division

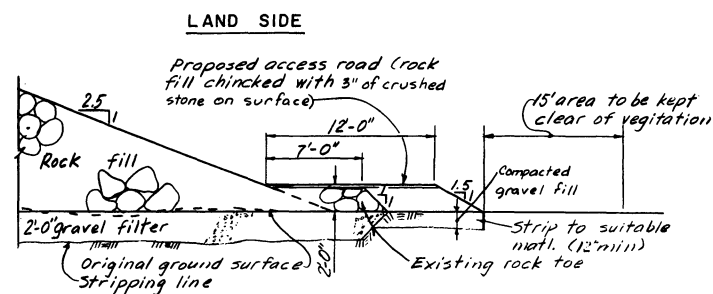
SECTION A-A
ACCESS ROAD ALONG DIKE (STA. 0+00 TO 12+00)

14. Existing Access. Access to the crest of the dike is provided by a gravel crest service road in fair condition. The crest service road is reached via a haul road in poor condition which extends from Weigold Road to the crest of the dike (see Plate No. C-1). Access to the downstream toe is limited to the lowering of equipment down the face of the dike. The downstream toe has a 7-foot wide rock berm which is not wide enough to allow access by construction equipment. Portions of the downstream toe are inundated by water from an adjacent swamp especially during high runoff periods, and vegetation including trees to 18-inches are growing along the rock toe limiting access and making inspection difficult.

15. Adequacy of Access. Access to the crest of the dike is considered adequate at this time provided the haul road from Weigold Road is improved. Existing access to the downstream toe is inadequate.

16. Recommended Improvements. The existing haul road from Weigold Road to the crest of the dike is in poor condition and should be improved by regrading, addition of minor quantities of gravel fill where needed, removal of obstructions including down trees and other improvements to insure that the design vehicles can reach the dike crest service road. No improvements to the crest service road are recommended at this time. The 7-foot wide rock berm at the downstream toe should be extended to 12 feet and all vegetation within 15 feet of the toe of the berm should be cleared to facilitate inspection (see Plate No. C-2). At the spillway end of the dike, the access route along the downstream toe should turn away from the embankment and follow the left side of the spillway discharge channel to the crest of the dike as shown on Plate No. C-1. This alignment will also improve access to the left side of the spillway discharge channel which is presently inaccessible during spillway discharge. Improvements to the wood road from Weigold Road to the crest of the dike is given low priority. Construction of the downstream toe access route is given low priority.

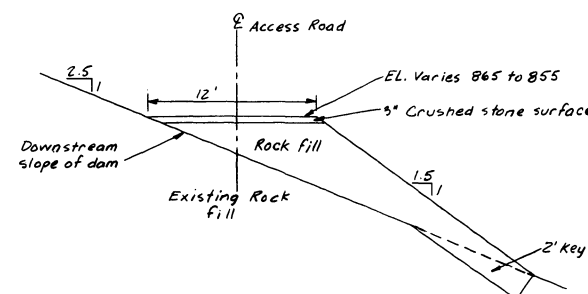
SECTION C-C
ACCESS ROAD ACROSS DOWNSTREAM
SLOPE OF DAM (STA. 8+00 TO 10+00)

2. Existing Access. The downstream toe from about station 6+50 to the outlet works at about station 8+65 can be reached from a cleared area starting at the original Route 72 on the downstream side of the dam. Surface runoff ponds at the downstream toe from about station 4+40 to about station 6+50 due to the topography in the area. This condition isolates the cleared area along the toe from the right abutment to about station 6+50. The toe from the outlet works to the left abutment is inaccessible other than by lowering equipment down the face of the dam. The downstream left abutment has slopes up to 50% and making this area of the toe inaccessible. The left downstream abutment toe is vegetated with trees and brush making inspection difficult.

3. Adequacy of Access. Access to the toe from about station 6+50 to the outlet works at about station 8+65 is adequate at this time. Access to the toe between the outlet works and the left abutment and from the right abutment to about station 6+50 is inadequate.

4. Recommended Improvements. A rock fill berm should be constructed along the downstream toe at elevation 875.0 MSL from station 6+90 to station 4+00 to allow access to the downstream toe at the right abutment from the original Route 72. A 12 foot wide rock fill access road with a crushed stone surface, approximately 200 feet in length, should be constructed to allow access to the downstream toe and spoil area between the left abutment and the outlet works from the downstream toe at the right side of the outlet works. The road should be constructed from the downstream toe at about station 8+00, across the downstream face of the dam above the outlet works to the downstream toe at about station 10+00. All vegetation along the downstream toe should be cleared to 15 feet from the toe, particularly along the downstream left abutment. Construction of the rock fill berm at the downstream toe of the dam is given low priority.
